DRAFT  
EVALUATION OF DIAMOND SHAMROCK  
SITE, PAINESVILLE, OHIO

June 18, 1981

Prepared for:  
U.S. Environmental Protection Agency  
Office of Enforcement  
Under Contract No. 68-01-6187

Prepared by:  
JRB Associates, Inc.  
8400 Westpark Drive  
McLean, Virginia 22102

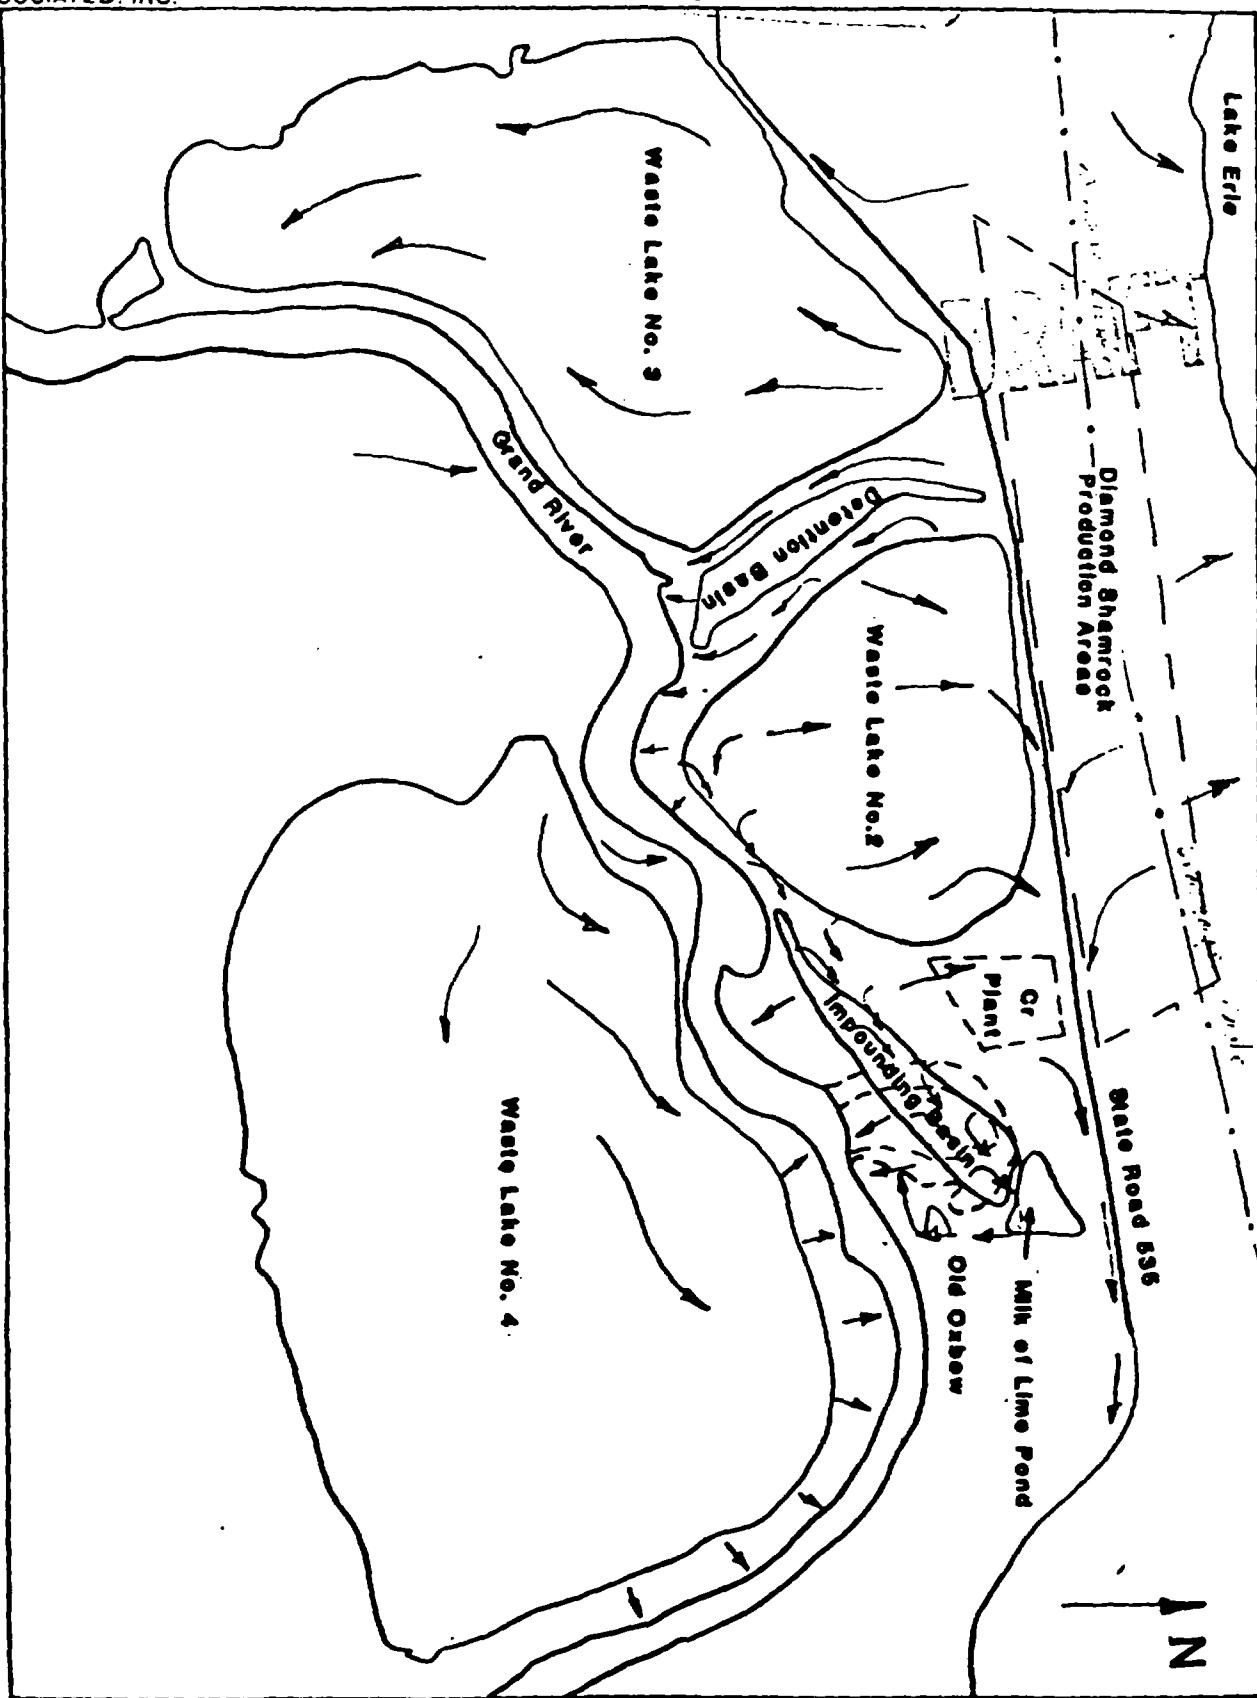
Figure 1: Drainage Pattern for Diamond Shamrock  
Production and Waste Management Areas  
(Post Diamond Shamrock Remedial Action)

This drainage basin is located on the northern edge of a dike, which parallels the Grand River and extends to the Milk of Lime Pond, where the surface drainage eventually migrates to the river. Areas along the north bank of the river and the extreme boundaries of the Waste Lake No. 2 and waste management areas mentioned above will be covered with fly ash, capped with clay, and countoured toward the Grand River (See Figure 1).

The surface drainage from the west detention basin, Waste Lake No. 3, and Waste Lake No. 4 remains uncontrolled. A majority of the run off from these waste areas is allowed to flow directly to the river.

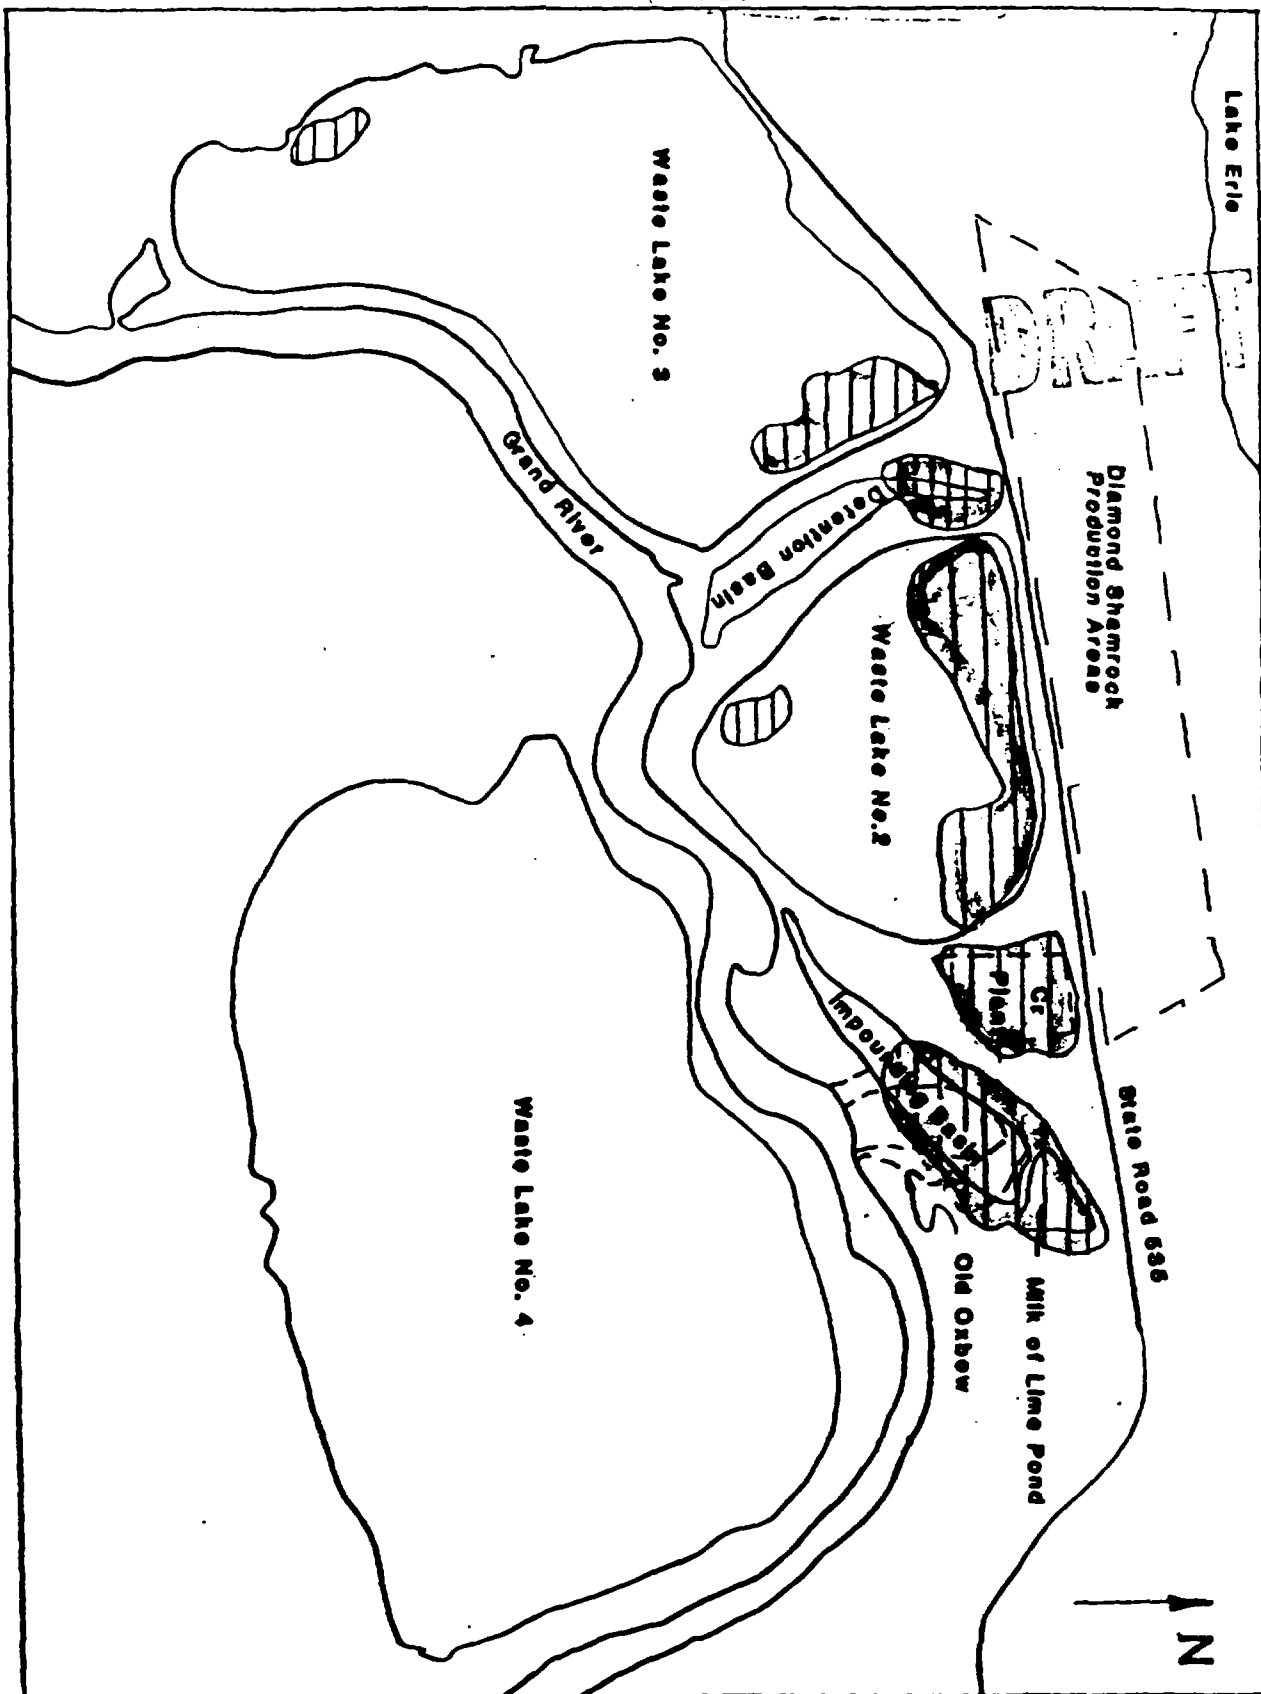
Figure 2: General Locations of Suspected Chromate Residues Disposal Areas

According to aerial photographs compiled by the EPA, suspected solid chromate residues have been dumped in the following areas (See Figure 2):

- o Along the northeast boundry of Waste Lake No. 3
- o On both sides of the northern neck of the west Detention Basin
- o Throughout the northern section and at a specific area in the southwest tip of Waste Lake No. 2
- o In and surrounding the east Impounding Basin.

Diamond Shamrock has reported that approximately three quarters of a million tons of these residues were generated at the chromate plant and dumped over an area of about 30 acres in the northeastern section of Waste Lake No. 2. During grading operation in 1974-1975 some of the residues were pushed over into the western portion of the Waste Lake. Based on the Diamond Shamrock information and the data compiled from the aerial photographs chromate residues have been distributed over a large area of

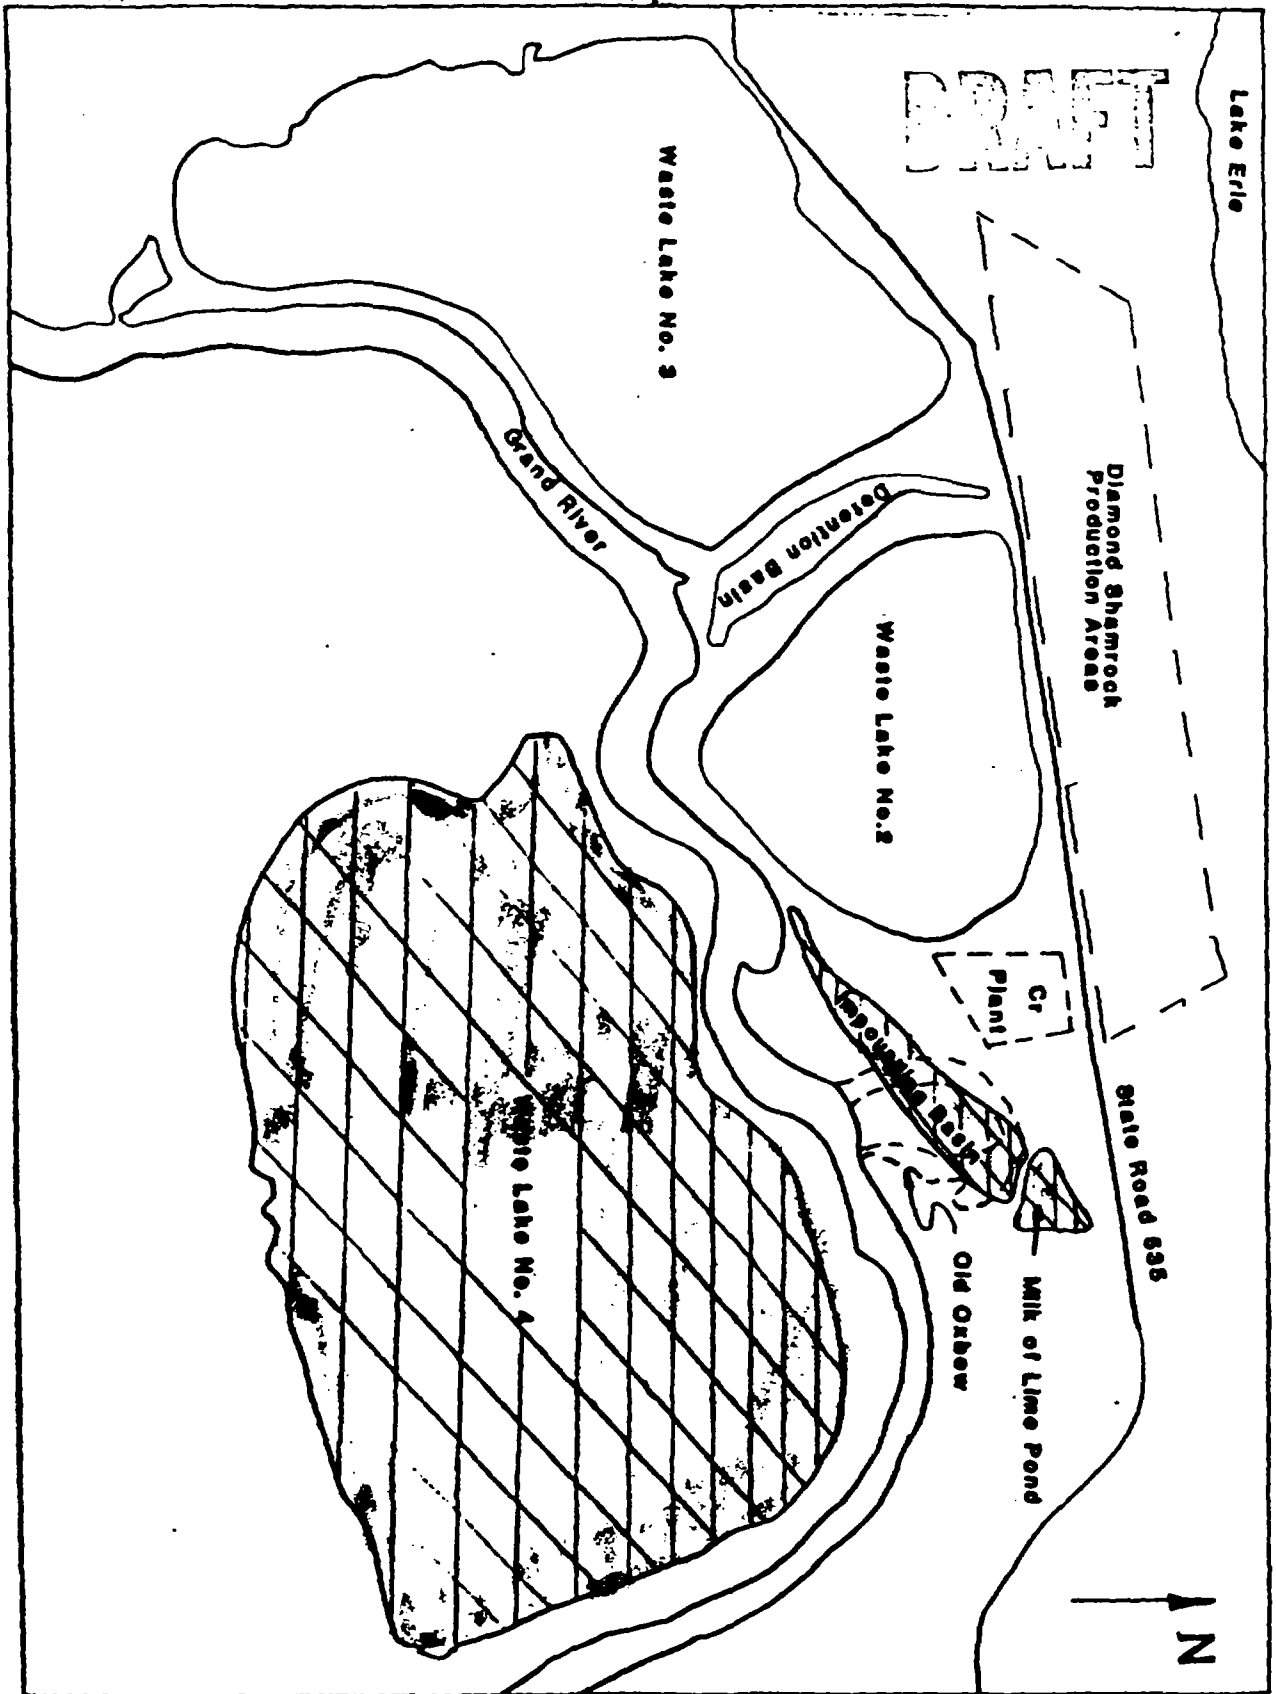
Figure 3: General location of Chromate Wastewater Treatment and Disposal Areas

The chromate wastewater were disposed of in two general locations after treatment. Initially the chromate plants proces wastewater were discharged to the Milk of Lime Pond to precipitate chromium before discharge to the river. The Impounding Basin located adjacent to the Milk of Lime Pond acted as a run off collection facility for surface drainage from the residue disposal area, and as a detention pond for the chromate plant's wastewater when the treatment facility was not operating (See Figure 3). In 1967 Diamond Shamrock modified the treatment procedures for the chromate wastewater by employing waste pickle liquor as a reducing agent and then comingling the waste stream with calcium carbonate waste from the solvay process in Waste Lake No. 4 to precipitate the chromates. This remained the method of treatment until operations ceased in 1972. The information reviewed to date indicates that chromate wastewaters were never discharged directly to the Grand River without treatment.

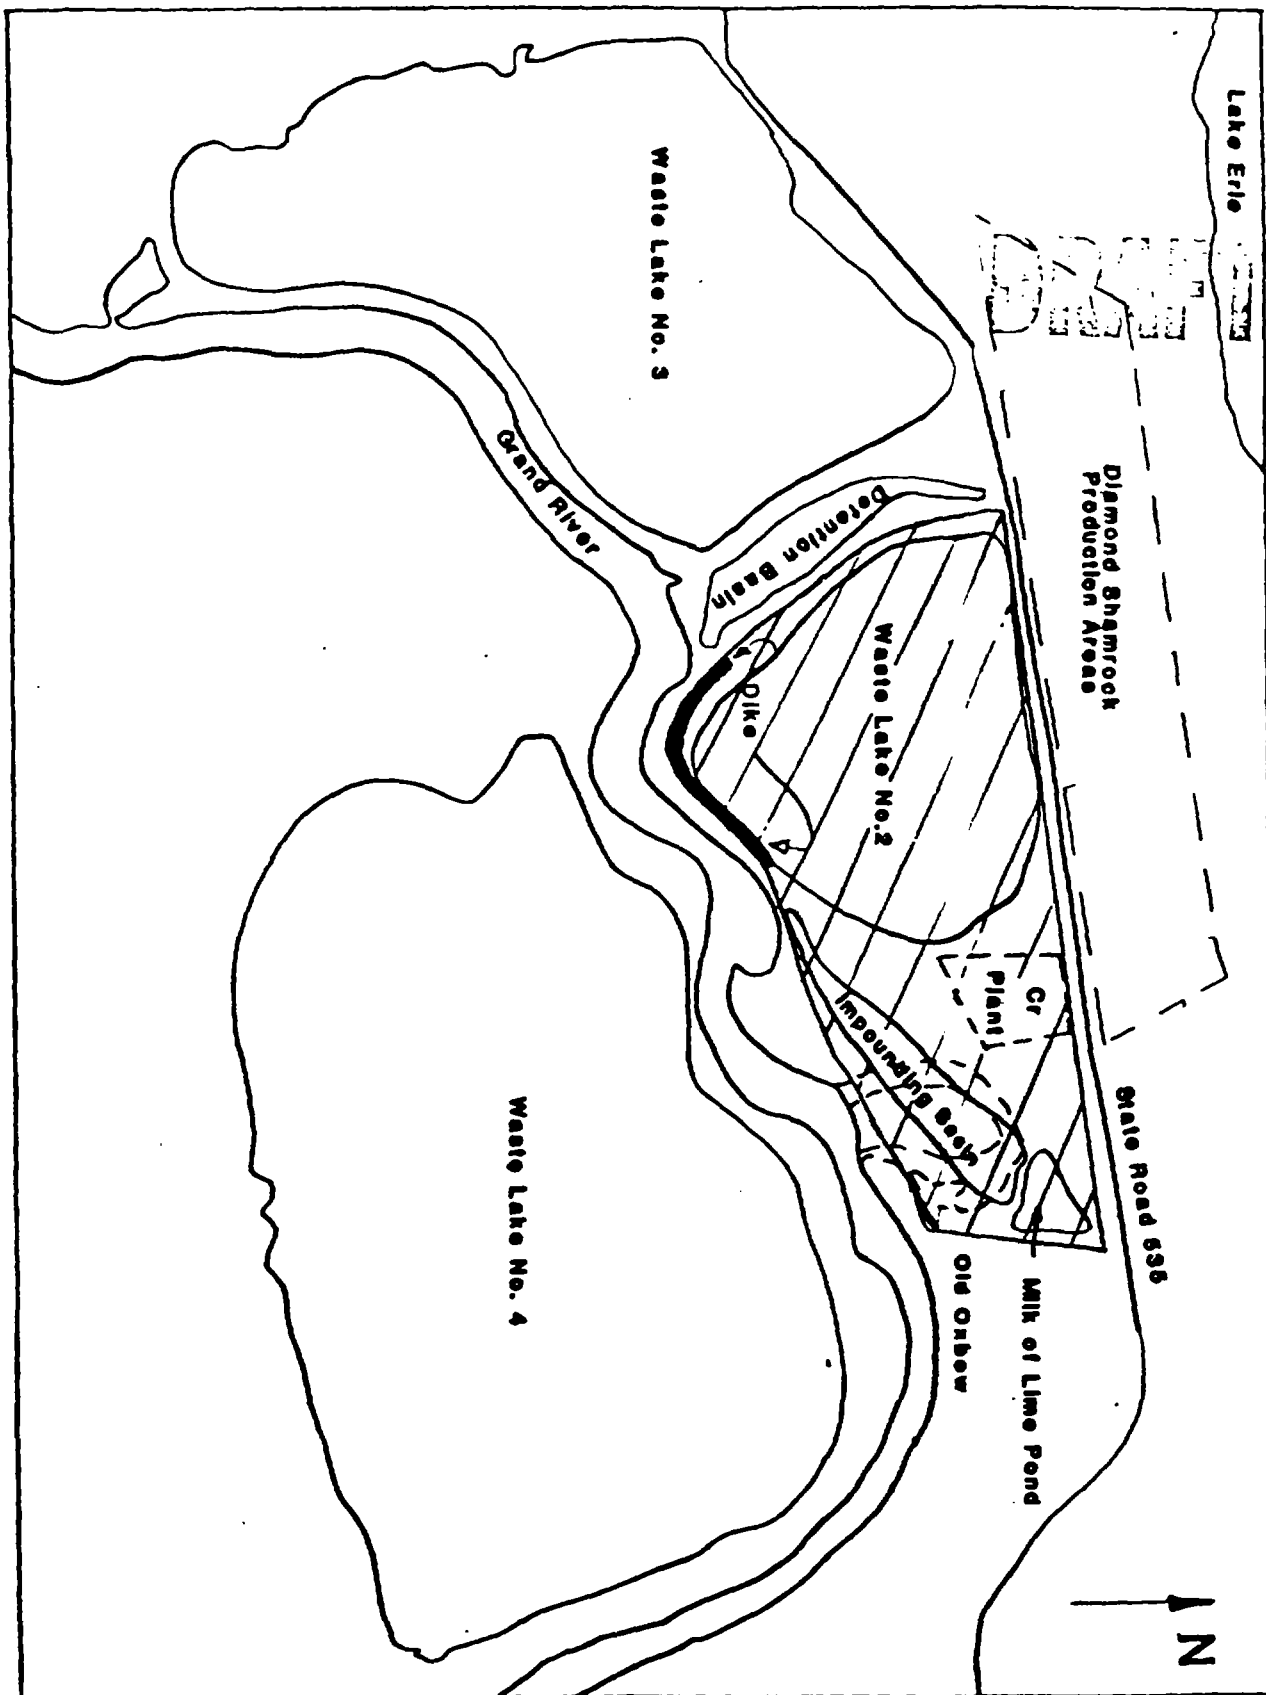
Figure 4. Approximate Area Currently Being Capped

The remedial program presently under construction by Diamond Shamrock consists primarily of clay capping, re-contouring re-vegetating the site. The area of chromate disposal affected by this remedial plan is approximately shown in Figure 4 .

Chromate wastes which were originally deposited near the banks of the Grand River have been moved back to the area shown in Figure 4 (See Section 2.0 for a description of waste disposal practices). The current capping procedures consist of:

- o Construction of a dike along the southern edge of Waste Lake No. 2 (See Figure 4 );
- o Fill in Waste Lake No. 2 and the impounding basin area with up to 6 feet of fly ash;
- o Cover the entire capped area with a minimum of 1 foot of clay, and;
- o Cover the clay with topsoil and seed with clover, vetch, and ryegrass.

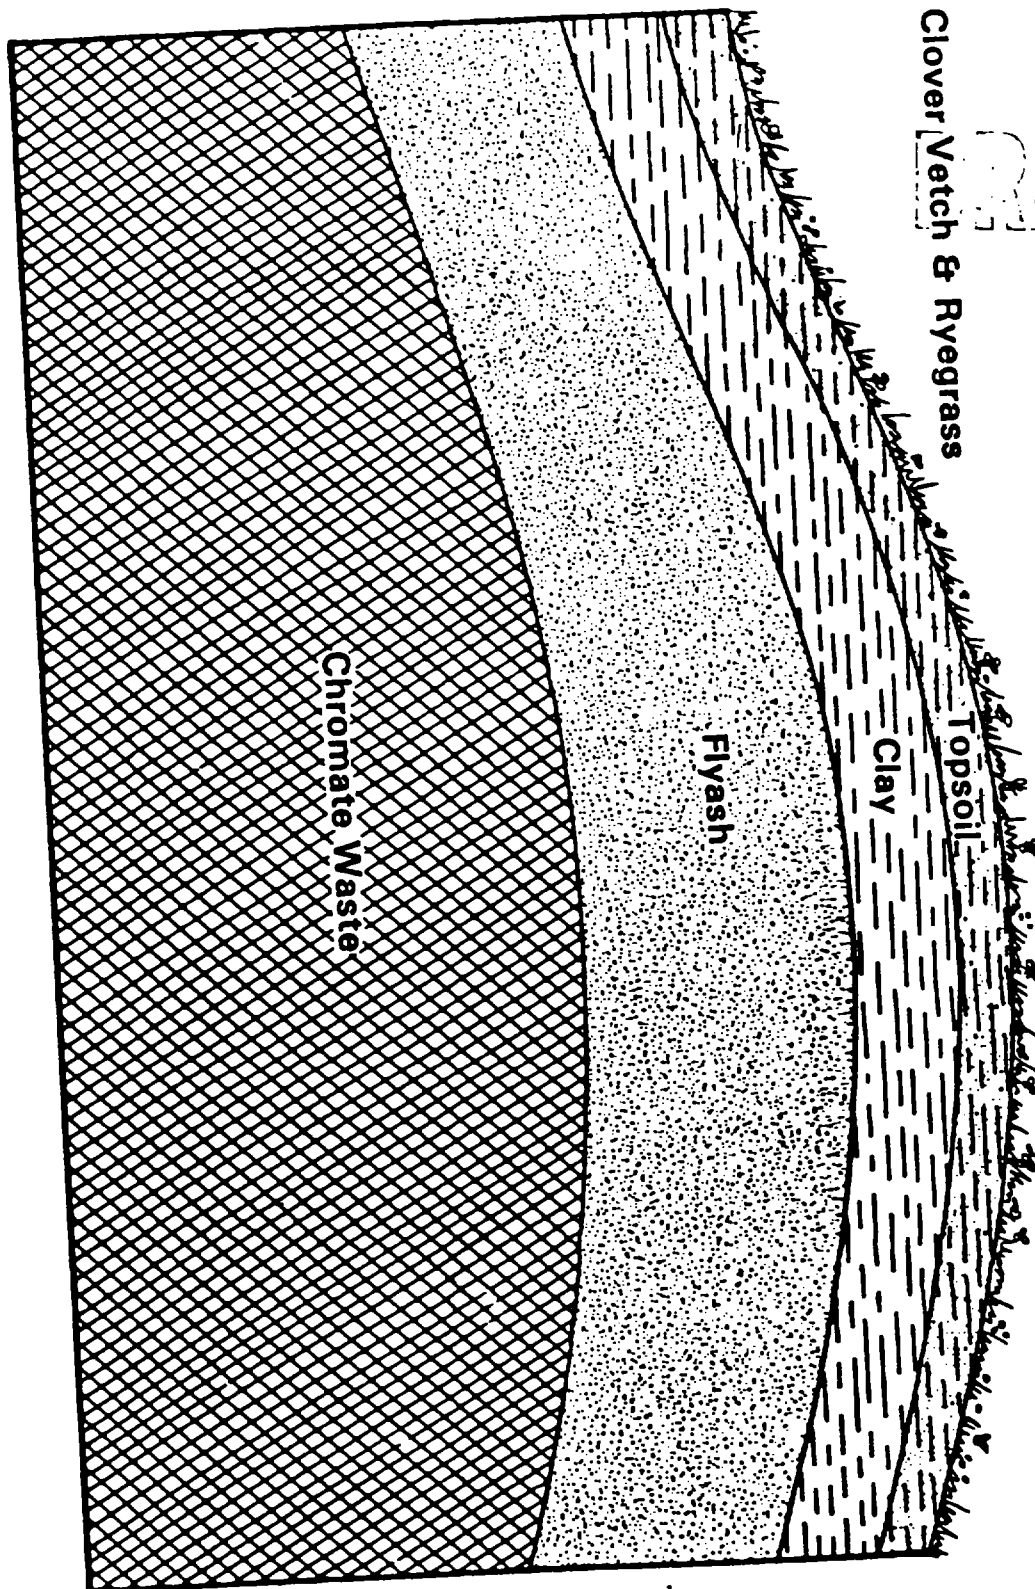
Figure 5. Cross Sectional Diagram of Clay Cap Under Diamond Shamrock's Remedial Program.

A cross-sectional diagram of the clay cap is shown in Figure 5. Based upon the current literature it is unclear as to what the final capping and contouring configuration will be. However, several problems may surface with time if this cap is the only remedial measure used at the site. These problems could include:

- o Migration upward of soluble chromate waste through capillary action;
- o Settling of the fly ash fill, resulting in depressions in the cap and/or (depending upon the thickness of the clay) cracking of the cap itself;

- o continual groundwater contamination from soluble chromate waste.

Fly ash, when used as a fill, will not totally retard the upward migration of soluble chromate waste and will only act as a temporary barrier. How long the fly ash fill will retard the upward migration of soluble waste is dependant upon its chemical composition and particle size distribution. It will be impossible to make this determination without further information.

The cap recommended for the site is the same as that agreed to by a Company involved in another EPA enforcement case. The recommended cap consists of:

- o Three feet of clay, compacted in six-inch layers to a maximum permeability of  $1 \times 10^{-7}$  cm/sec.
- o One six - inch layer of sand tilled into the clay
- o One six - inch layer of topsoil seeded with native vegetation.

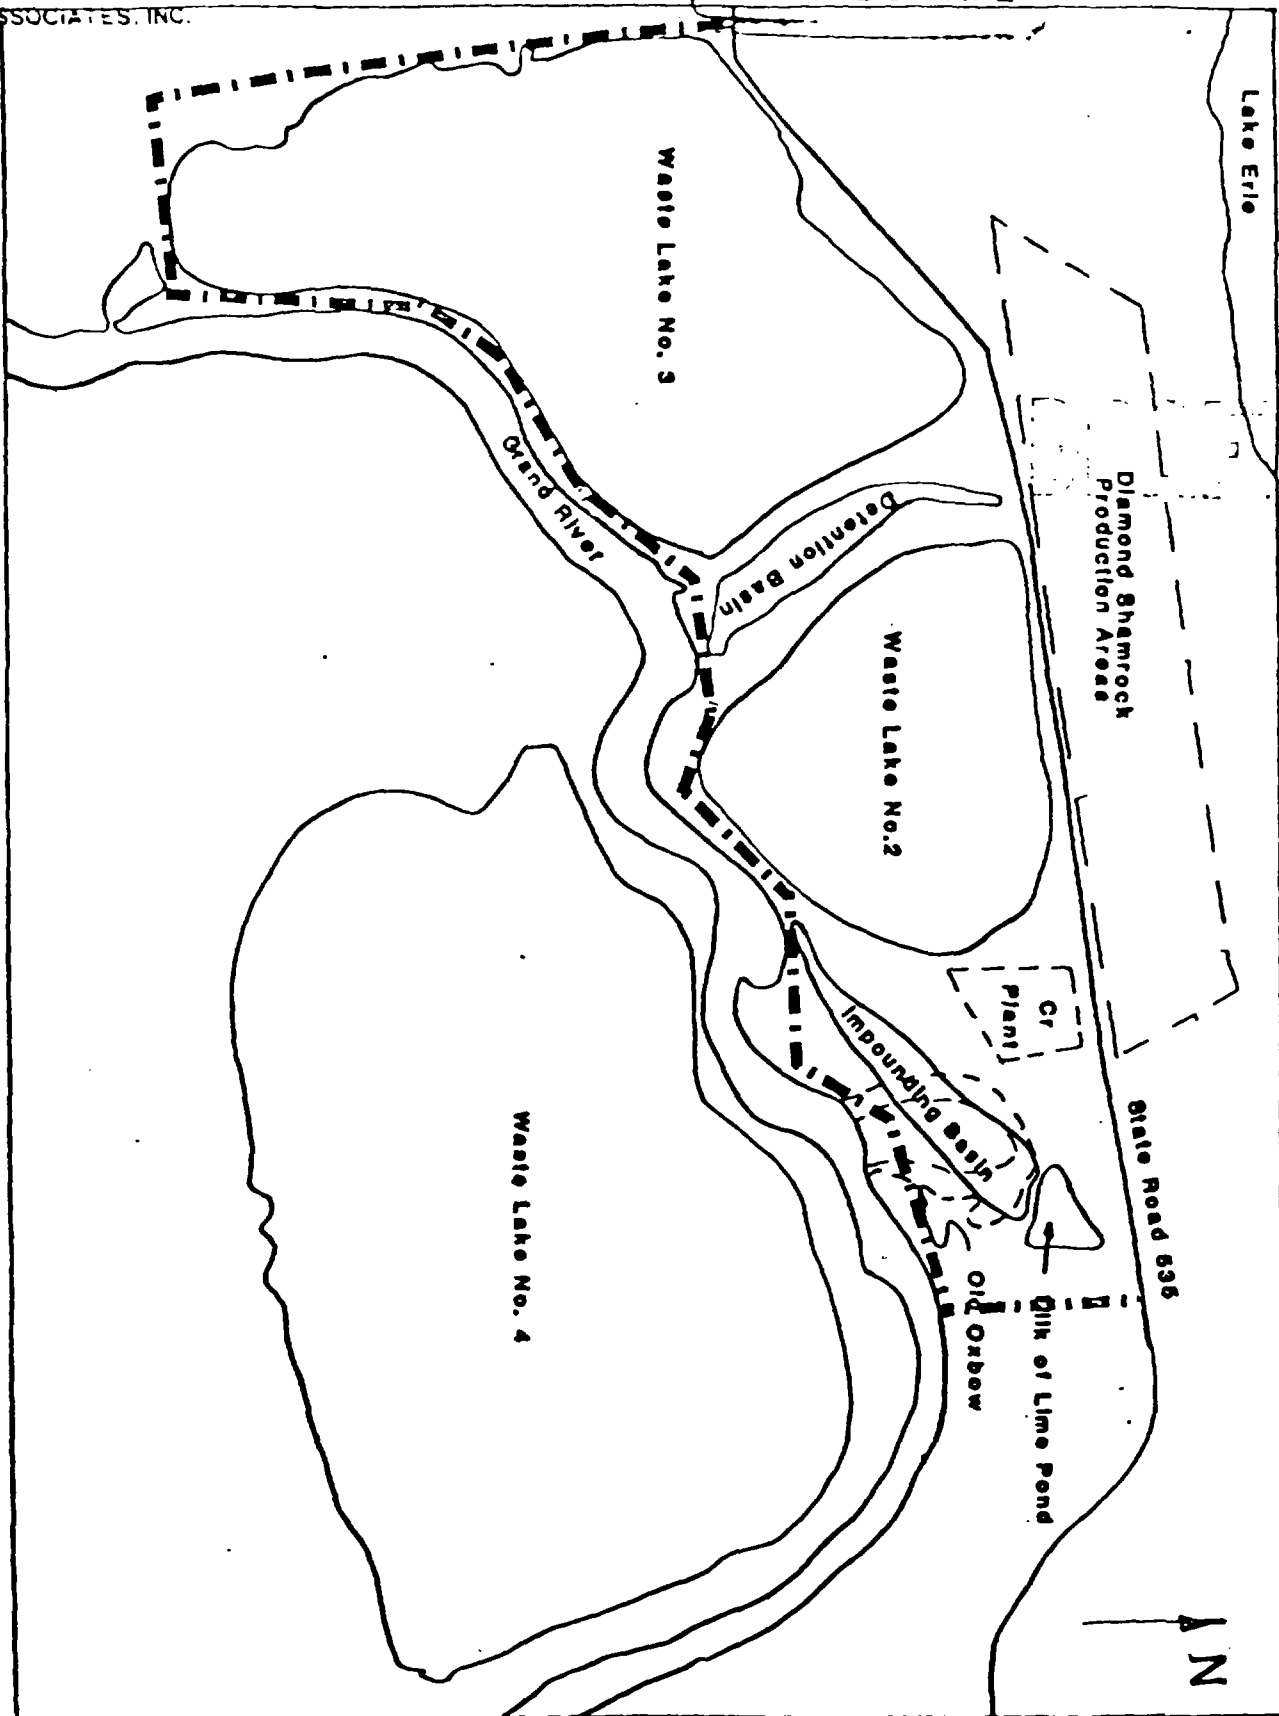
Figure 6. Approximate Locations of the Proposed Slurry Wall.

According to available information, the dikes used to form waste lakes at the site were not keyed into impervious clay layers underlying the site. Therefore, we believe that a major pathway for migration of wastes was to exit the site between the bottom of the dike and the underlying clay layer. Therefore, the recommended remedial action includes construction of a slurry trench cut-off around the sides of the site as shown in Figure 6. To be effective, the cut-off should be placed partially into the blue clay layer underlying the site.

Although depth of this layer from the surface is not available from enough well logs or soil boring data to define completely it appears that an average depth of 25 feet can be assumed based on the scattered data that is available. Length of the slurry trench will be about 14,000 feet.
